## IV. Analysis and Evaluation

The analysis and evaluation of the cultural landscape for the Lincoln Memorial grounds are based on an examination of the historical records and the documentation of existing landscape resources in the study area. A summary discussion of the cultural landscape components documents landscape patterns, relationships, and individual features within a site, which define the character of the designed landscape. With this information, the overall significance and integrity of the landscape is addressed according to national register criteria for landscapes.

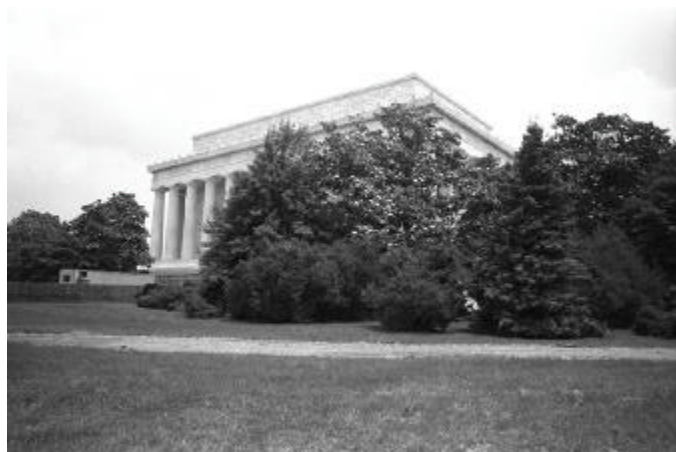
Figure 68- Existing west side foundation plantings, July 23, 1996. LINC 10-17.

The trees and shrubs surrounding the memorial currently exhibit different degrees of health and reflect a range of growing conditions. Along the front or east side, the plantings have suffered greatly from the effects of repeated construction activity and preparation for large-scale public events that have occurred in this area over time. The 1995-96 construction on the approachway has caused further damage to the foundation plantings. The lack of routine maintenance and regular pruning has also caused some of the plantings to appear ragged or

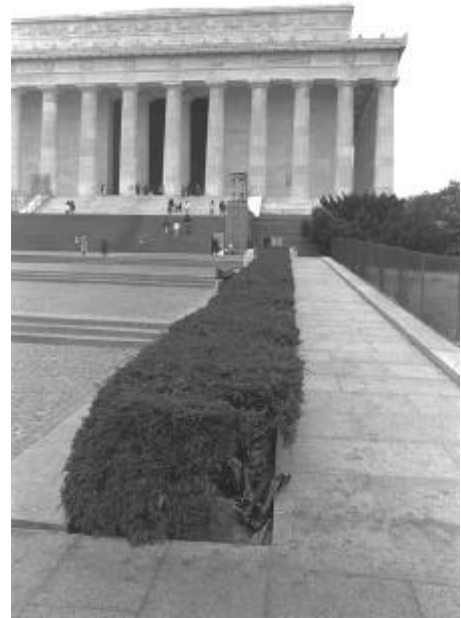
*Figure 69 - Existing yew hedge along approachway and accessible ramp, January 3, 1997. LINC 16-21.*

overgrown. When the park revised the original plans by replacing the boxwood hedges with yews in 1945, they altered the character of the entry planting, yet retained some of the historic integrity by keeping a band of green hedge growing on both sides of the approachway. However, the addition of an American holly and the Japanese hollies to the front side and massings of yews to screen floodlights have further compromised the character of the planting design. Because replacement plantings have deviated from the original design, the landscape on the front side retains a lower degree of integrity. On the sides and rear of the memorial, the integrity of the plantings is mostly intact, although some boxwood planted near the magnolias and close to the raised terrace have been shaded out and are unhealthy, or have died. At the midpoint of the north and south sides, two thick masses of *Taxus cuspidata* 'Nana' provide the horticultural transition between the character of the two different planting areas. Even though these yews were planted to replace the original mugo pines, the design intent of keeping a lower growing conifer mass in this area is still evident. In other areas overgrown plant material, like some American hollies that were planted on either side of the horizontal-growing yew mass on the north face of the memorial, are encroaching upon the designed opening above the raised terrace. See Map 15 and Map 16 *Lincoln Circle - Vegetation* for the graphic representation of the front and back plantings.

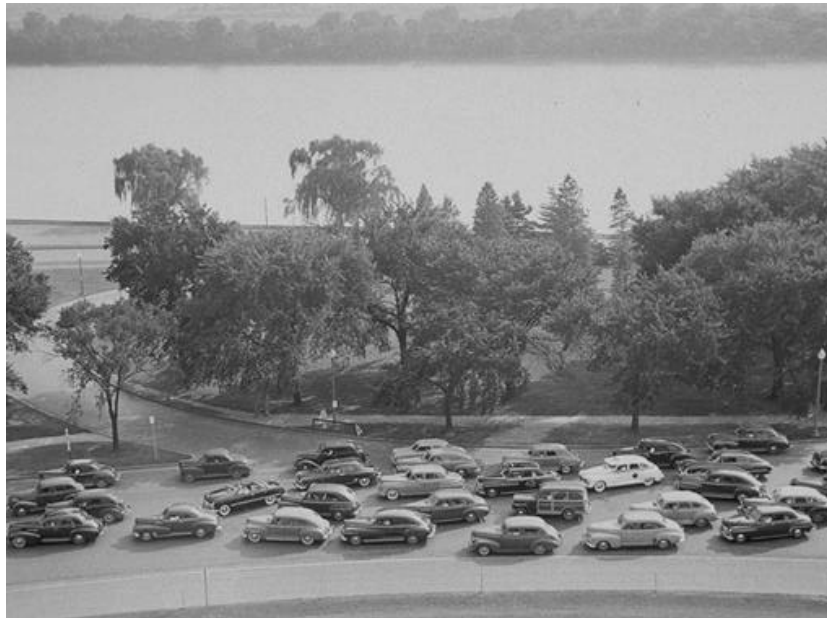
*Figure 70 - Rush hour traffic around Lincoln Circle, c. 1944. MRC 2-4.*

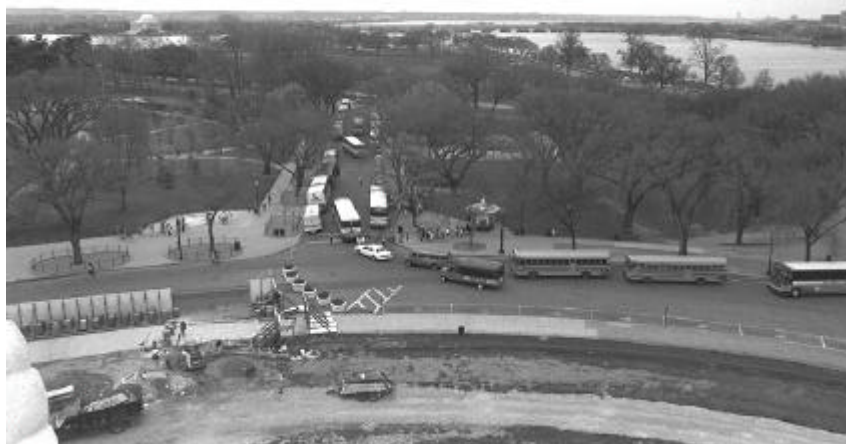
*Figure 71 - Traffic congestion on French Drive and Lincoln Circle, March 1996. LINC 6-34.*

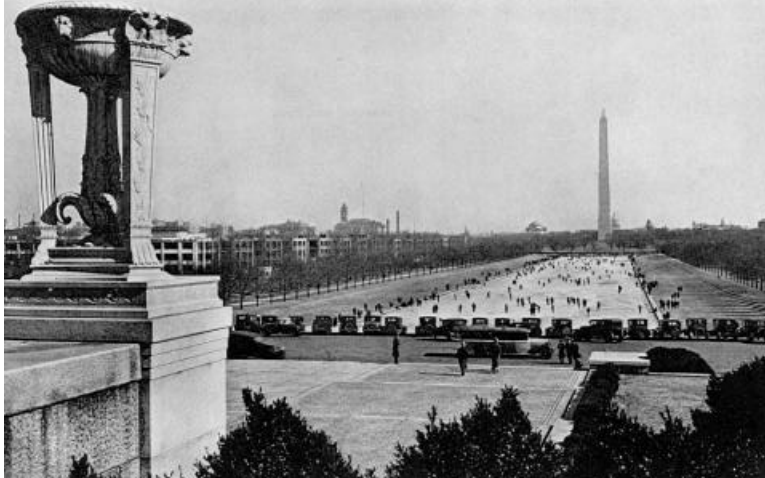
**Figure 72 - Unofficial parking area at top of Reflecting Pool steps and Lincoln Circle, 1929. Used by permission from the National Geographic Society.**

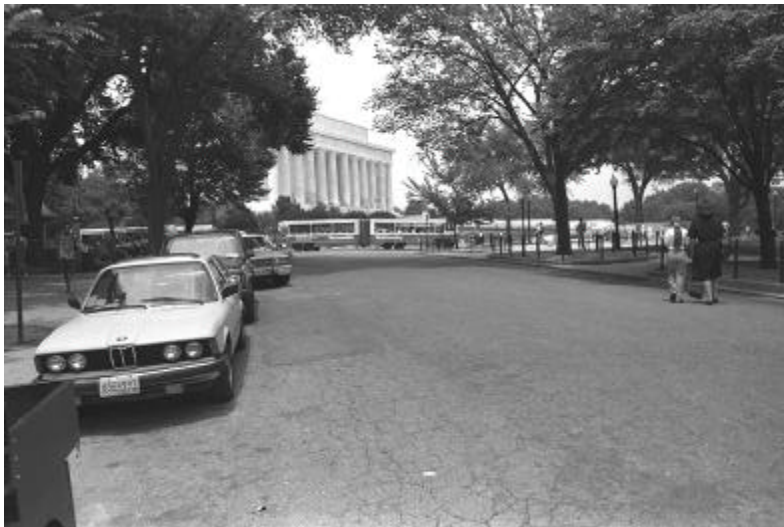
**Figure 73 - Bus and taxi drop off along French Drive, July 23, 1996. LINC 10-14.**

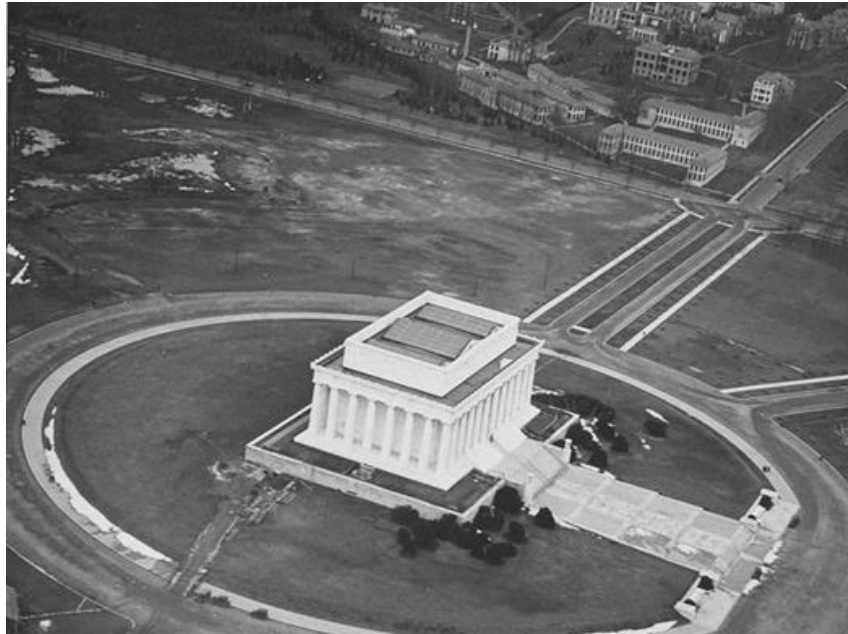
*Figure 74 - Initial sidewalk installation, February 13, 1922. U.S. Navy photo. MRC 1-61.*

**Pedestrian Circulation.** The 1916 plans developed for the memorial and the surrounding areas showed a range of treatment for the various types of proposed pedestrian and vehicular routes. The plans established a hierarchy of circulation for both use and materials, with the more formal in the immediate vicinity of the memorial. The main entry to the memorial, the approachway, was paved with granite and cobblestone, creating a stately surface (further detail is presented in the “Structures” discussion for the Lincoln Memorial circle and radial roads). Around the Lincoln Circle the material changed, a 15-foot-wide concrete sidewalk was placed along the inside circumference, while a concrete sidewalk, only 8 feet wide, was placed between the first and second circular band of elms, along the outside

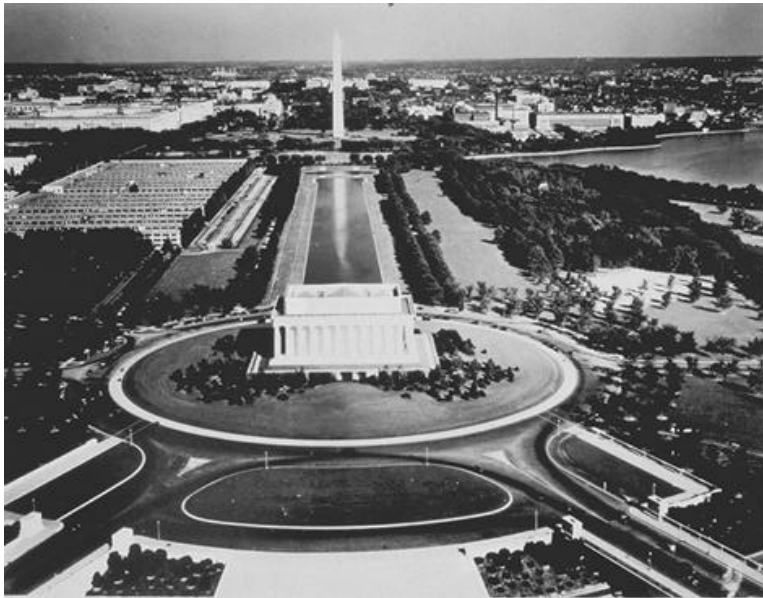
**Figure 75 - Painted crosswalks from Lincoln Circle to the sidewalks along the radial roads and approaches, 1934. MRC 1-67.**

At Lincoln Circle, pedestrian crosswalks were painted at all intersections with the radial roads and the approachway (1932 photo documentation). However, from that time forward, pedestrians crossing from any point on the circle encountered hazardous traffic conditions, especially on the east side of the memorial. To provide a safe, unimpeded place for crossing, the National Park Service began limiting vehicular traffic to the eastern segment, between French and Bacon Drives, during the 1972 tourist season.

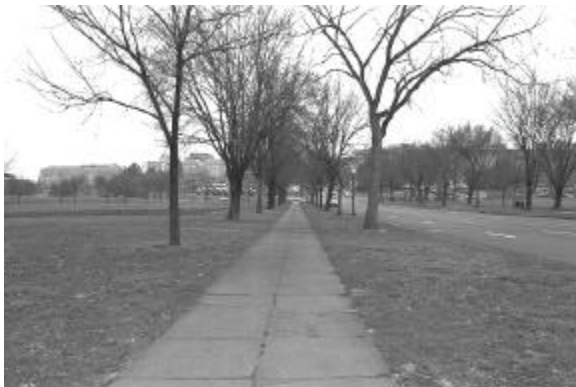
**Figure 76 - Eight-foot wide sidewalk along 23rd Street NW, January 3, 1997. LINC 16-13.**

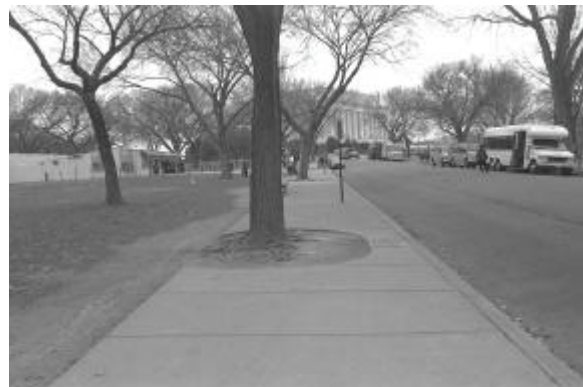
**Figure 77 - Nonhistoric layout of sidewalk along west side of French Drive, December 5, 1996. LINC 13-13.**

changes included extending sidewalks to the curb edge, the creation of individual tree planting beds with raised curb edges, and the addition of post and chain barriers to protect both the trees and the adjacent lawn. Many of the changes to the outer circular sidewalk and French Drive have been compounded with further additions brought on by the Korean War Veterans Memorial and by the perpetuation of nonhistoric site features. On the opposite side of the Reflecting Pool steps, at the Vietnam Veterans Memorial, the sidewalk width has been maintained, but it too is edged

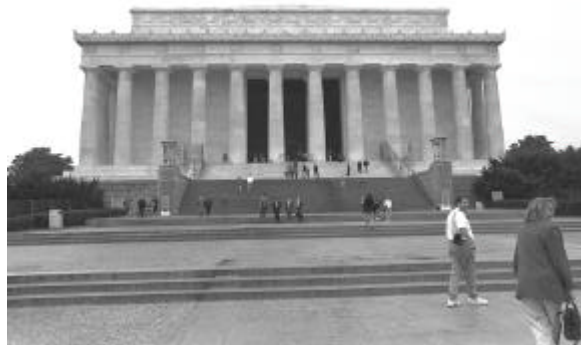
*Figure 78 - Approachway and Lincoln Memorial, January 3, 1997. LINC 16-20.*

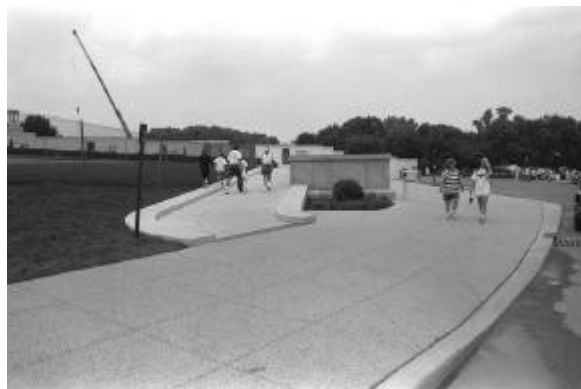
*Figure 79 - Reconfigured accessible ramp to Lincoln Memorial, July 23, 1996. LINC 10-7.*

stones from dislodging. Also the ramps were redesigned to meet current accessibility standards according to the Americans with Disabilities Act (ADA) and provide a wider path for visitors. The new ramps have a more gentle slope (5%) and are 9 feet wide, 3 feet wider than the old ramps. As a result of the reduced slope of the ramps, the coping on the planting bed retaining walls needed to be raised 11 inches. Another course of granite and new granite coping (due to the deteriorated state of the original coping) were placed on top of the existing walls. The last change to the structure was the realignment of the ramps where they met the inner circle sidewalk. The previous ramps had a blind curve where the ramp and sidewalk came together. This situation was corrected to give visitors a clearer view when descending the ramp. Although the ramps are not historic, the National Park Service treated this area with the same respect for the historic fabric as they did for the main entrance steps by integrating the redesign of the ramp into the original approachway design. By using granite paving instead of exposed aggregate for the ramp surface, and by defining the edge of the ramps with granite coping, the ramps appear to be a part of the approachway.

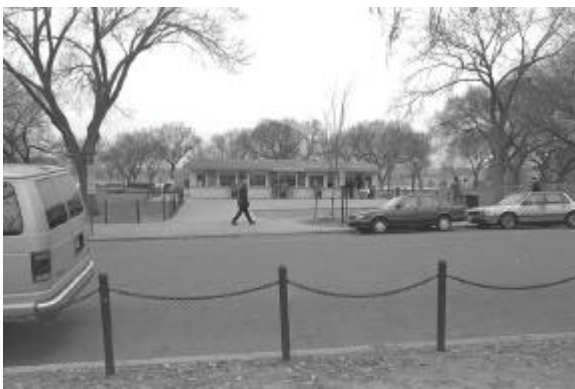
**Figure 80 - Refreshment stand along French Drive, December 5, 1996. LINC 13-18.**

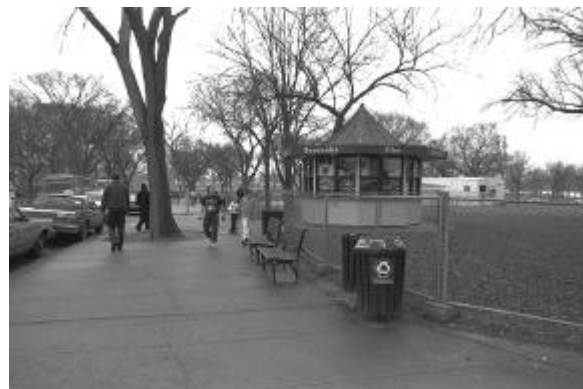
**Figure 81 - Gift shop kiosk along French Drive, January 3, 1997. LINC 16-25.**

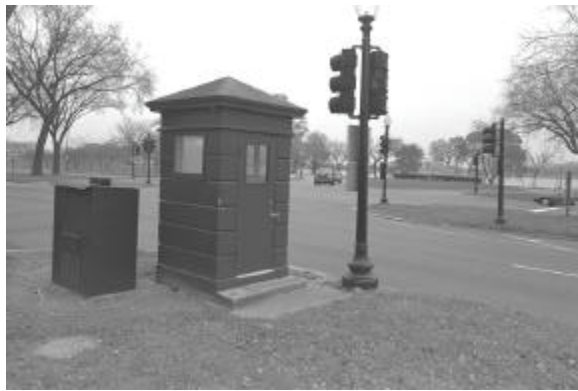
*Figure 82 - Guard Stand at the intersection of Independence Avenue and 23rd Street SW, December 5, 1996. LINC 13-8.*

Another minor structure is a guard stand at the intersection of Independence Avenue, Ohio Drive, and 23<sup>rd</sup> Street SW. After the completion of Independence Avenue in the 1940s, the National Park Service placed this 5-foot by 5-foot structure to provide shelter for a traffic officer. The officers controlled the traffic light and setup barricades at this intersection to direct one-way traffic on the Rock Creek and Potomac Parkway during rush-hour. It is rarely used today. See Map 19 *Lincoln Memorial circle and radial roads - Structures* map for location of structural features.

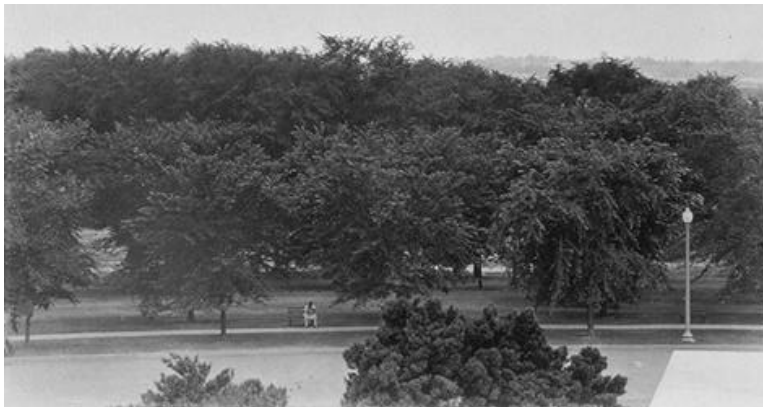
*Figure 83 - Cast iron frame benches were placed along the outer circle sidewalk, June 25, 1931. MRC 2-70.*

**Benches.** The earliest photographs show benches around the outer sidewalk of the eastern segment of the circle, facing the memorial. From subsequent photographs, it does not appear that benches were initially placed along the sidewalks lining the radial roads. In the 1960s benches were placed in the areas around concession stands and bus dropoffs to provide seating for visitors. Benches were also concentrated along the outer circle sidewalk between Bacon Drive and the Reflecting Pool and between the Reflecting Pool and French Drive. When the Vietnam Veterans Memorial was completed in 1982, additional benches were placed along the newly created path linking this new memorial to the Lincoln. When the concession trailer was removed from its site between the Reflecting Pool and French Drive to the southwest side of French Drive, all the concession area benches were also removed and relocated with the structure. The type of bench used during the 1920s and 1930s is similar to the present bench, a cast-iron frame with a wooden slat seat and back. In response to the changes in visitor needs, benches are no longer evenly distributed over the wider Lincoln Memorial area as was done originally, but are concentrated near concession activities.

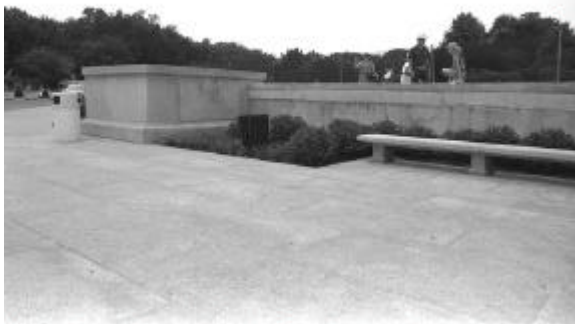
*Figure 84 - Two types of trash receptacles located in the front planter by a granite bench, July 23, 1996. LINC 10-5.*

the receptacles were also moved to French Drive. Generally trash receptacles and receptacles for recyclables are placed next to every bench that is along French Drive. Wire-type trash receptacles have been placed near ballfield backstops located in the grassy areas on the north between the radial roads. A variety of trash receptacles were found on the approachway during a study conducted in the early 1990s. The selection found there at that time included the "tulip," a pre-cast concrete trash receptacle and an upright metal type. These same three types are still used along the approachway. A tall white metal cylinder-type stands at the base of the approachway steps. A "tulip" has been positioned in both of the approachway planting beds on either side of the granite benches. And several pre-cast concrete trash receptacles are positioned at every elevation change for the approachway. None of the receptacles are compatible with the formal setting of the Lincoln Memorial.

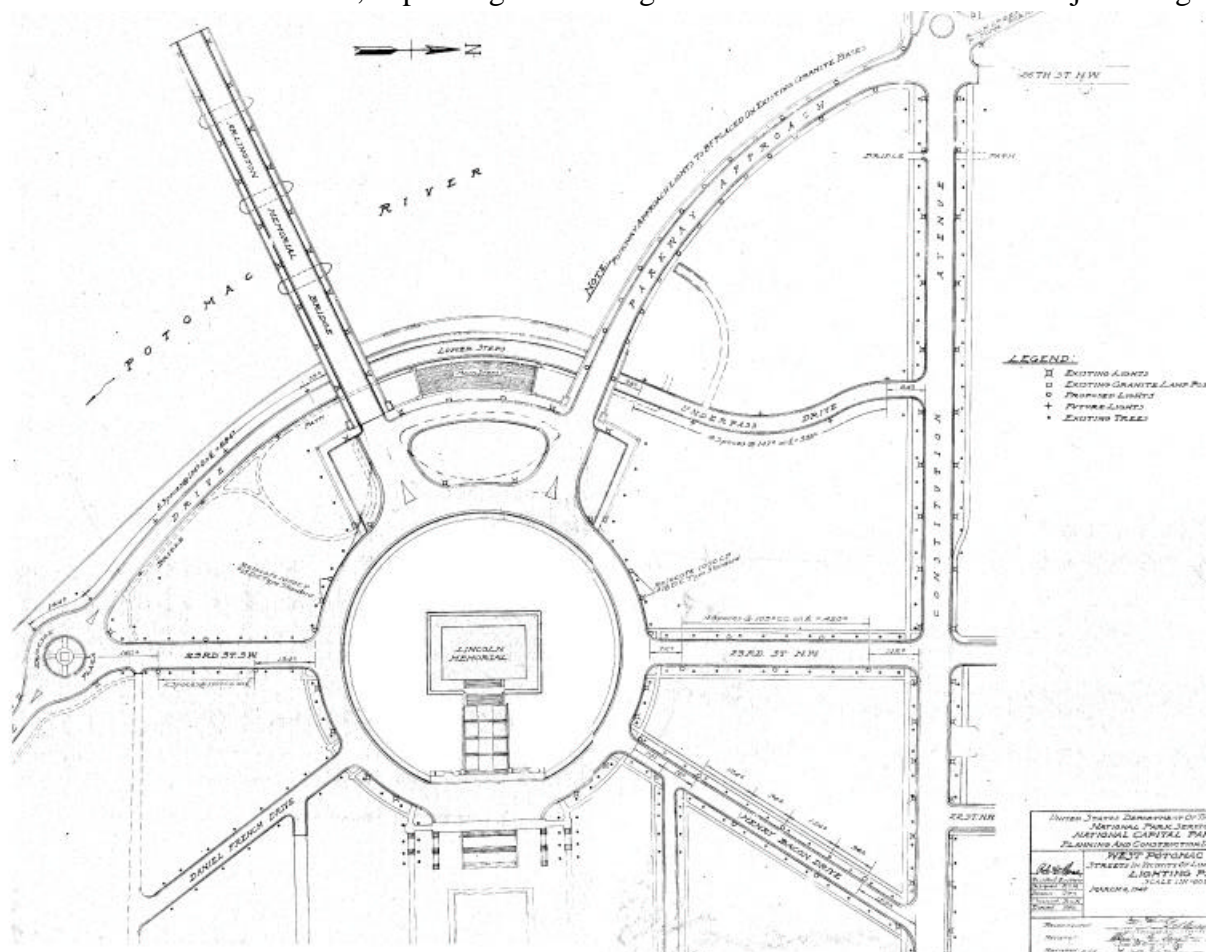
Map 20- Lighting Plan for West Potomac Park, 1940. NPS Map 76-321

**Lighting.** In Henry Bacon's original vision for the Lincoln Memorial, the structure and the surrounding grounds were to be lit exclusively by moonlight. Shortly thereafter, Bacon conceded to the installation of street lamps around the outer circumference of the Lincoln Circle and along the radial roads. The "Washington Globe" lights were selected. These were made up of an acorn, lamp style, and a cast-iron post. The post was painted a light gray color. Spaced approximately 75 feet apart on the traffic circle, the primary function of the streetlights was to provide illumination for the roads and walkways around the Lincoln Memorial, and not to light the interior of the memorial. Eighteen-foot high lampposts were placed around the circle to provide greater amount of illumination, since they were to be placed only along the outer circle. Subsequent improvements to the lighting occurred in 1927 when the CFA approved a plan to provide lighting in the statuary chamber. Another street lighting plan developed in 1940 refined the first plan. A few existing posts were relocated along the outer edge of the circle and a shorter version of the "Washington Globe" streetlight was installed along all the radial roads except French Drive. Shorter 16-foot posts were spaced alternately at even intervals, varying between 96 feet to 110 feet on-center, depending on the length of the radial road. The last major change

was in 1969, when flood and spot lights were installed near the raised terrace wall to illuminate the exterior of the memorial structure. In 1972 the National Park Service proposed a lighting plan for French Drive, but it was never implemented. At some point after 1933, the lamppost were painted black, which differs drastically from the original light gray color.

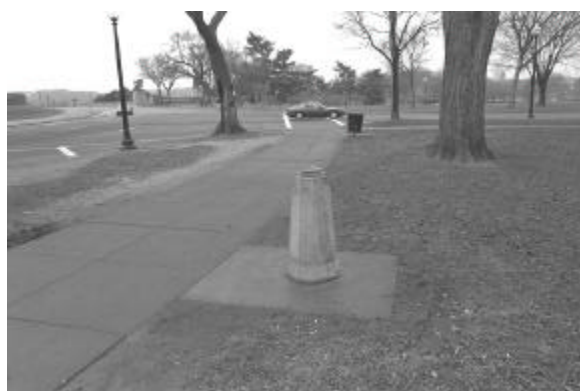
*Figure 86 - Concrete drinking fountain located between 23rd Street NW and Bacon Drive, January 3, 1997. LINC 16-16.*

**Drinking Fountains.** The 1916 design did not specify the use of drinking fountains, but according to photo-documentation, the Office of Public Buildings and Public Parks did installed drinking fountains along the outer circle by 1927. In 1996 two of the original concrete drinking fountains were documented to be adjacent to the outer sidewalk on the segment located between Bacon Drive and 23<sup>rd</sup> Street, NW and near the southwest corner of the intersection of Constitution Avenue and 23<sup>rd</sup> Street, NW. An accessible drinking fountain was installed at the lower end of each of the two ramps constructed along the memorial approachway in 1976. However, these were removed when the ramps and approachway were rehabilitated in 1995-1996. When reviewing the proposed modifications to the approachway, the CFA commented on the inappropriate design of the fountains at this particular location. Presently, the two old concrete fountains, a single accessible drinking fountain located southwest of the southern Reflecting Pool walk (1995), as well as accessible fountains near the adjacent playing fields on the south, and at the entrances to the Vietnam and Korean War Memorials all provide water to visitors. The newer fountains conform to current design standards for West Potomac Park and the Mall.

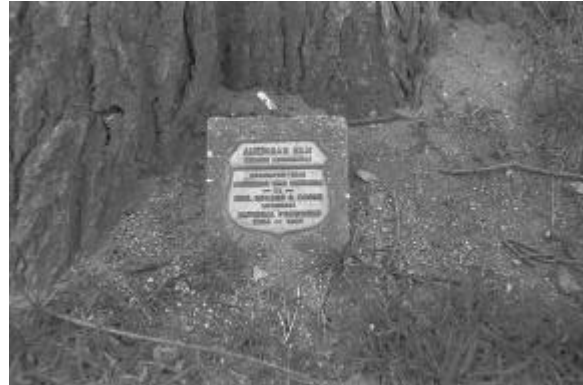
*Figure 87 - Memorial planting shield located along the Lincoln Circle, April 1996. LINC 7-2.*

**Signs.** In the 1930s, the National Park Service continued the efforts of the Office of Public Buildings and Grounds (OPBG) and Office of Public Buildings and Public Parks (OPBPP) by providing a marker for the majority of memorial trees within the Lincoln Memorial area. A bronze shield, inscribed with the names of the dedicated individual or group, were embedded into a concrete base. There were three different installations proposed for the markers; flush to the ground; raised up above the ground on a slant; and a post above ground, straight. Over the years the markers have been damaged and removed or buried by grade increases near the base of the trees. Repair and replacement of the damaged markers stopped in the 1960s. Because of the lack of support for the maintenance of the memorial tree program in the Lincoln Memorial area, only two markers are left. Both of the markers are located between French Drive and 23<sup>rd</sup> Street SW. Since the creation of the first planting plan in the 1916 up until the implementation of the landscape design for the west side of the memorial in 1932, memorial trees and the markers have been an important site feature of the commemorative landscape.

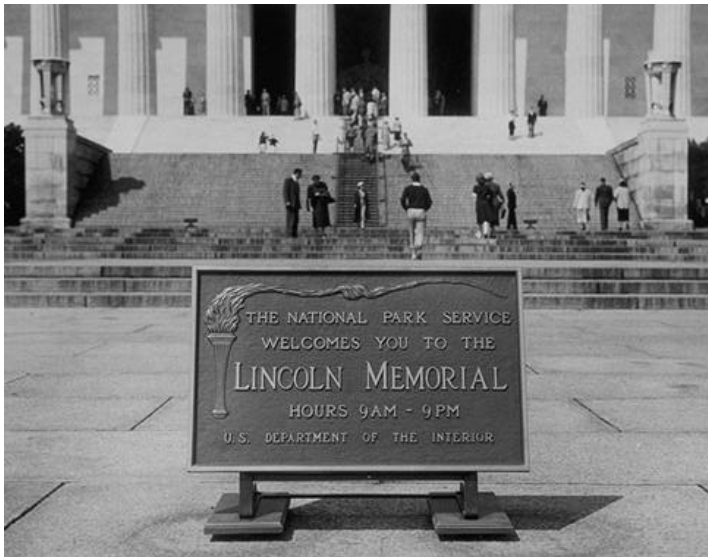
*Figure 88 - Bronze sign placed along approachway, April 16, 1952. MRC 1-44.*

In the 1950s and 1960s, a bronze sign placed in a central location on the approachway, indicated the visiting hours for the Lincoln Memorial. It appears that the low-profile sign was never permanently mounted to the paving.

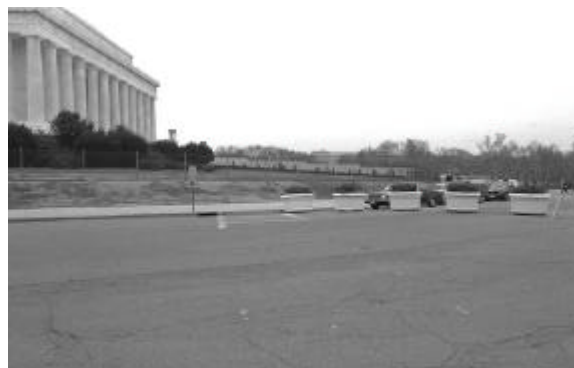
*Figure 89 - Planter barriers on Lincoln Circle, December 5, 1996. LINC 13-20.*

**Traffic and Pedestrian Barriers.** A variety of traffic barriers are used to control vehicular traffic around the circle. These include concrete planters, jersey barriers and flexible delineators. All the barriers add visual clutter and detract from the formal and geometric setting around the circle.

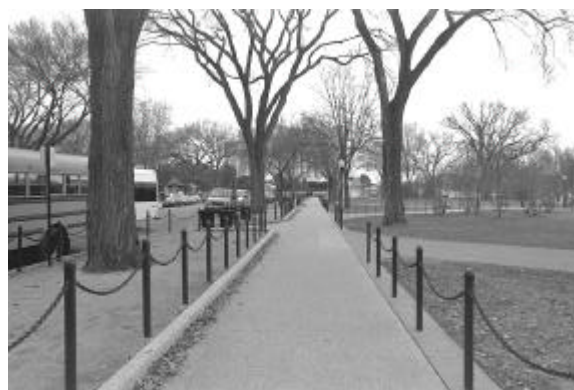
*Figure 90 - Stake and chain barrier along French Drive, December 5, 1996. LINC 13-15.*

For pedestrian areas, four different types of barriers are used: post and chain; stake and chain; stake and rope; and snow fence. Park maintenance has installed these fences for a variety of reasons, but overwhelmingly for the control of visitor circulation. The most formal and most predominant is the post and chain. Most of the posts are installed in a metal sleeve set in the ground for easy removal. Although the second type, the stake and chain, is less widely used, it also prevents pedestrians from walking on grass and in planting beds. The other types, the stake and rope and/or snow fence, provide temporary protection of newly seeded areas and control circulation during special events.

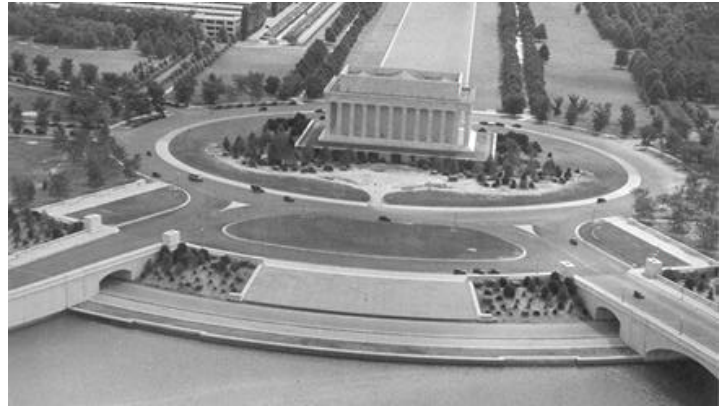
*Figure 92 - Aerial view of Watergate planting beds during installation of plants, July 29, 1932. U.S. Army Air Corps photo. MRC I-134.*

the consulting landscape architect for the Arlington Memorial Bridge Commission. Greenleaf, in turn, directed Irving Payne, landscape architect from the Office of Public Buildings and Public Parks, in formulating a final planting plans for the Watergate steps area. Payne's plan included some of the same species planted within the Lincoln Circle, such as American holly, yew, and boxwood. These were planted in an informal arrangement in the beds formed by the

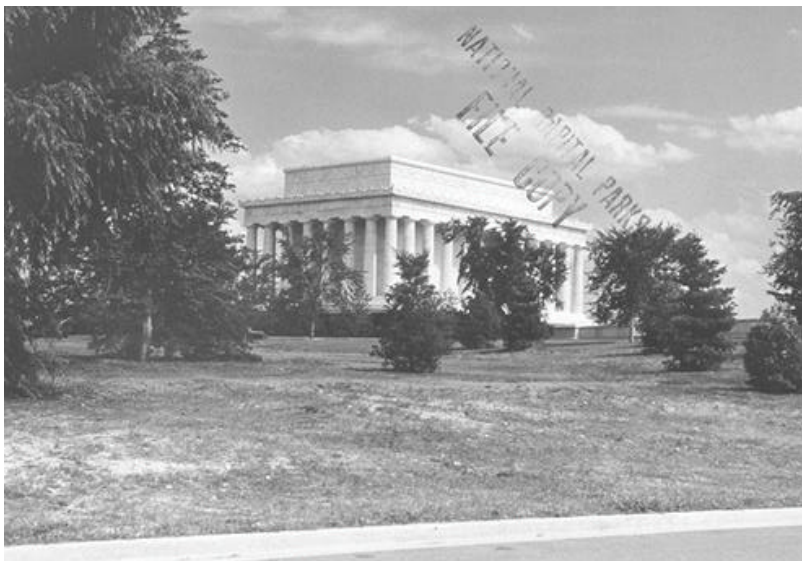
*Figure 93 - View of native planting on slope near the north plaza wing wall, July 19, 1933. MRC 2-80.*

bald cypress (*Taxodium distichum*), deodar cedar (*Cedrus deodara*), swiss stone pine (*Pinus cembra*), and mugo pine trees were added for height and mass to the far slopes adjacent to the north and south wing walls. Pink and white dogwoods (*Cornus florida*) were also added to provide interest during all seasons. Other native understory plantings, such as redbud (*Cercis canadensis*), birch (*Betula* sp.), and sassafras (*Sassafras albidum*), were proposed for both sides of the wing walls, but were probably never planted.

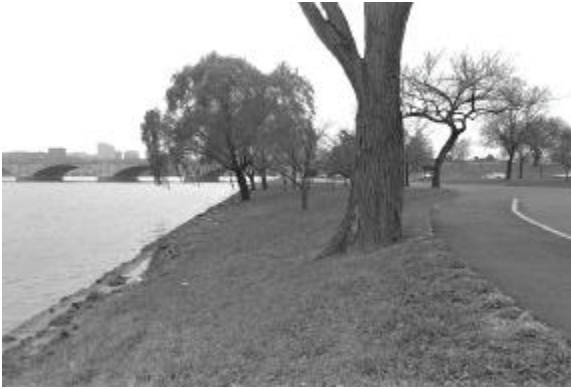
**Figure 94 - Riparian vegetation planted along portions of the Potomac River shoreline, December 5, 1996. LINC 13-11.**

Other proposals specified a continuation of informal plantings of weeping willows (*Salix x elegantissima*) and understory vegetation along the river's edge. Because only a few of these trees were ever planted, the density of vegetation intended for this area never fully developed. As a result, open views to the river have persisted and are now preserved for the enjoyment of pedestrians, bicyclists, and

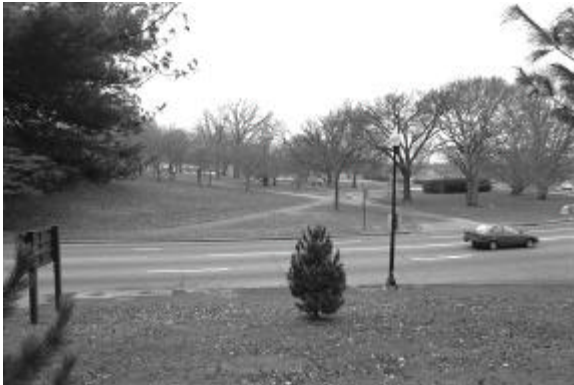
**Figure 95 - Informal planting of memorial tree grove (naturalistic grove), January 3, 1997. LINC 16-10.**

The greater the distance from the symmetrical design of the circle and the radial roads, the more informal the proposals for treatment became. The planting plans for the recreational areas west and northwest of the memorial were therefore informal in character. A grove of native, deciduous trees were planted here in the 1930s and 1940s as part of the memorial tree program. The exception to this was the row of American elms that lined the northeast side of Parkway Drive from the north Watergate wing wall to the terminus of Constitution Avenue. Again, as in the other informal areas, understory plantings were proposed but never planted during the initial stages of development. Subsequent additions

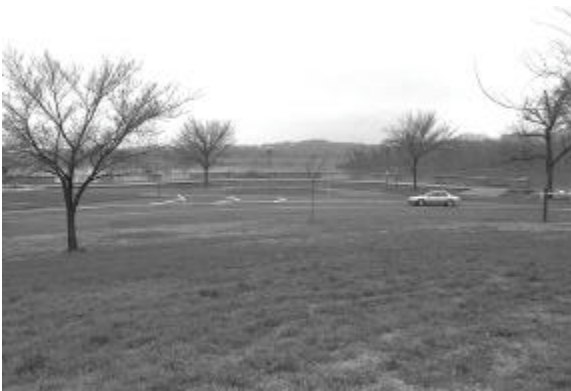
**Figure 96 - Old Constitution Avenue terminus and remnant row of elms, January 3, 1997. LINC 16-5.**

Along Constitution Avenue, a double row of American elms lined the road. At the western terminus, the formality continued. Two elms were planted in a small grassy area, and a circular planting bed surrounded by pavement marked the end of the avenue. Even after the realignment of Constitution Avenue in the 1960s, for the construction of the off ramps for the Roosevelt Bridge, a line of elms still follow the old alignment to the Potomac shoreline, where the terminus has remained unchanged since its construction in

the 1930s. The only possible change to the terminus are seasonal flowers that have been added to create interest to the formal circular bed. There is no documentation on how this circular area was proposed to be used after its installation.

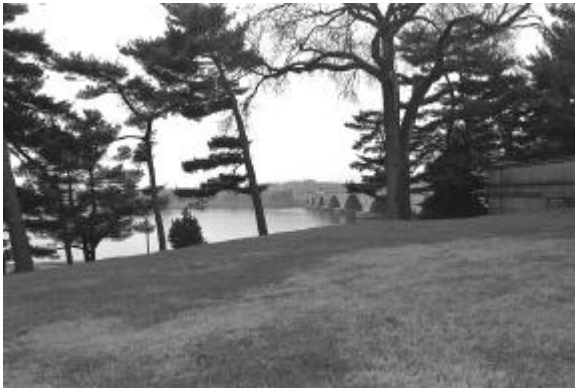
***Figure 97 - White pines, American elms and mugo pines frame view to Arlington Memorial Bridge, January 3, 1997. LINC 16-31.***

Even with the changes in the landscape, much integrity from the original Arlington Memorial Bridge Commission planting plan remains. The transition from the more formally planted drives to the informal groupings of shrubs and trees on the grassy slopes is still intact. The tall picturesque white pines, bald cypress, and deodar cedars continue to frame the view from the top of the Watergate steps across the Potomac to the Virginia shoreline. Some flowering dogwoods still survive underneath these large trees, though these natives have been replaced in recent years with Kousa dogwood, which have a different, less open growth habit.

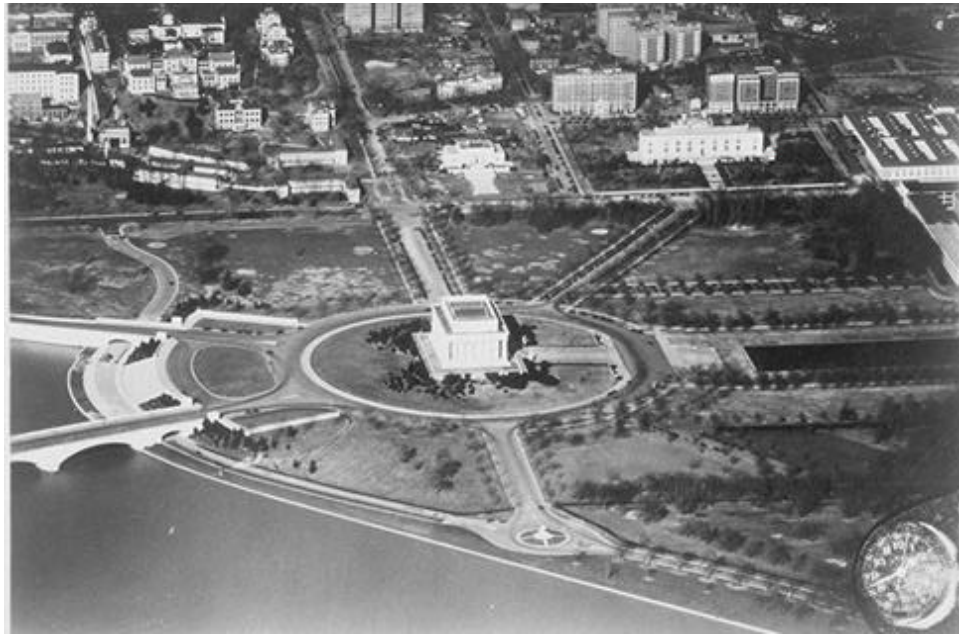
*Figure 98 - Aerial view of completed road system for the Watergate area, July 1937. U.S. Navy photo. MRC 1-64.*

**Vehicular Circulation.** The development of a shoreline drive, with bridle and foot paths, along the Potomac River shoreline in 1907, marks the beginning of road construction for this component landscape. When the development of more formal roads around the Lincoln Memorial occurred in the 1920s, the shoreline road was modified to accommodate these changes. Remnants of the old roadway are still visible along sections of present-day Ohio Drive, southeast of the Ericsson Memorial.

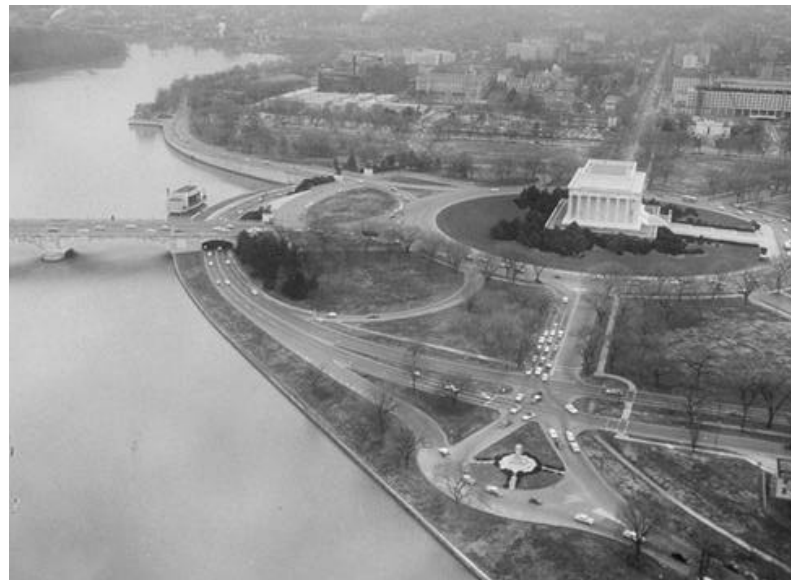
**Figure 99 – Aerial of Independence Avenue and cloverleaf pattern before construction of Theodore Roosevelt Bridge, January 27, 1960. MRC I-108.**

Significant road improvements occurred in the 1940s when the D.C. Department of Highways and the Public Works Administration constructed the western extension of Independence Avenue through West Potomac Park. The new extension met the drive (Ohio Drive) north of the Ericsson Memorial and followed an easterly route on an alignment of an older east/west park road. At this time, a cloverleaf configuration was also constructed

north and south of the Watergate steps plaza to accommodate the increase in traffic and to provide safe on/off ramps from Ohio Drive to Lincoln Circle and the approaches. The traffic islands at the circle were enlarged at this time to control traffic from the approaches to Lincoln Circle. The previously granite block pavers filling in the islands were removed in favor of grass.

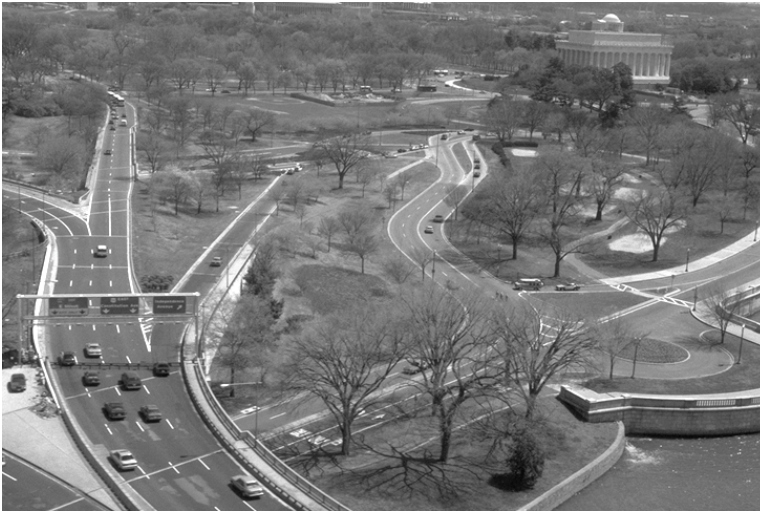
**Figure 100 - Aerial view of Roosevelt Bridge and its connection to Constitution Avenue and Ohio Drive, April 1996. MRC 3-27.**

The last major change in vehicular circulation occurred in 1964 with the completed construction of a segment of a proposed inner loop freeway and the Theodore Roosevelt Bridge across the Potomac River. The impact of a new network of roads on Constitution Avenue, west of 23<sup>rd</sup> Street, was significant. The on/off ramps required for the bridge and freeway made the previous configuration of Constitution Avenue impossible to maintain. The Constitution Avenue approach to the formal terminus was thus eliminated in favor of curving ramps and new access roads. In 1984 the road at the top of the Watergate steps was removed and sodded over, but the granite curb remained along the sidewalks edge.

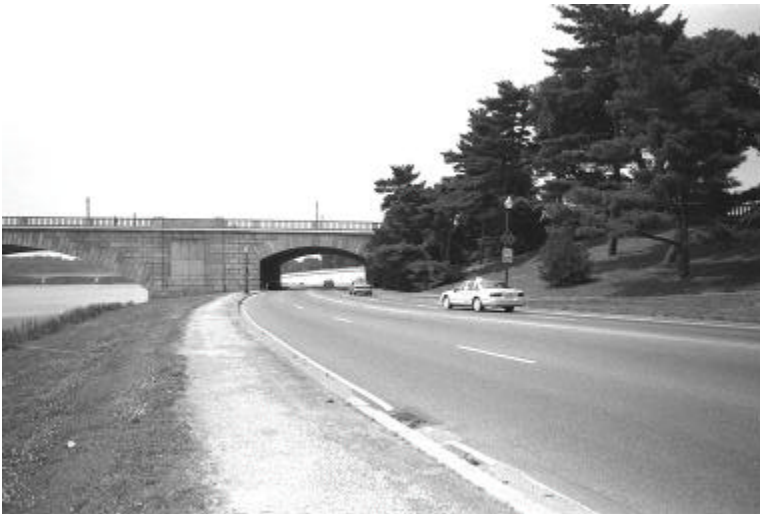
**Figure 101 - Ohio Drive (Riverside Drive) and underpass for Arlington Memorial Bridge, June 1996. LINC 9-11.**

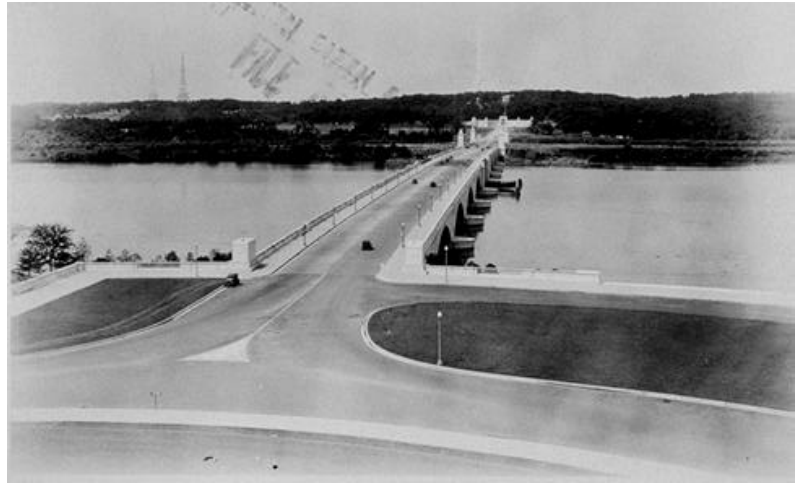
*Figure 102 - Completed sidewalk and bridle trail by south plaza wing wall, June 9, 1933. MRC 1-75.*

**Pedestrian Circulation.** As a part of the development of a shoreline drive after the turn of the century, bridle trails and pedestrian paths, designed to parallel the road, were incorporated into the overall plan for the roadway. The existing system of paths was modified in the 1930s when the layout of the roads was changed as part of the construction of Arlington Memorial Bridge and Rock Creek and Potomac Parkway. Plans called for a bridle trail to wind through the golf course area in the northwestern corner of West Potomac Park near the parkway, to cross the underpass drive on the north side of the bridge plaza, to pass directly in front of the Watergate steps, to continue southeast along the underpass drive along the slope, or to curve up around the slope of the south wing wall of the bridge plaza toward a second route, which followed the inbound lane on Arlington Memorial Bridge. Along its route, the trail surface was mostly a soil base. However, in the underpasses and in front of the Watergate steps, the trail was paved in square granite blocks.

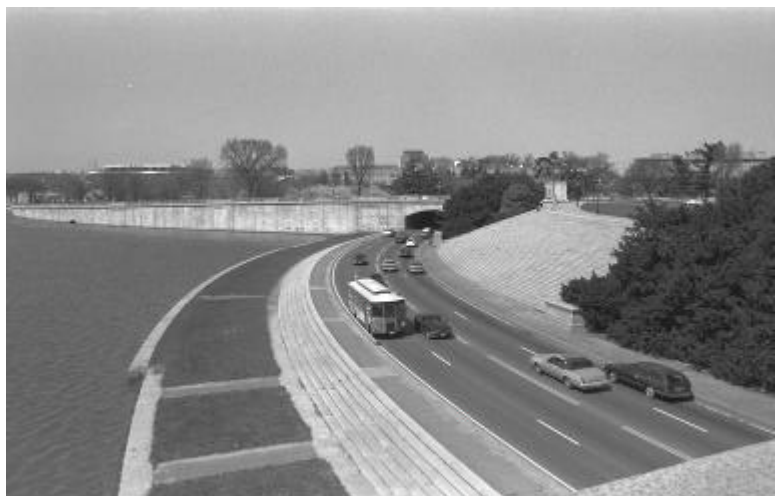
*Figure 103 - Walkway on either side of Ohio Drive at base of Watergate steps, April 1996. LINC 6-15.*

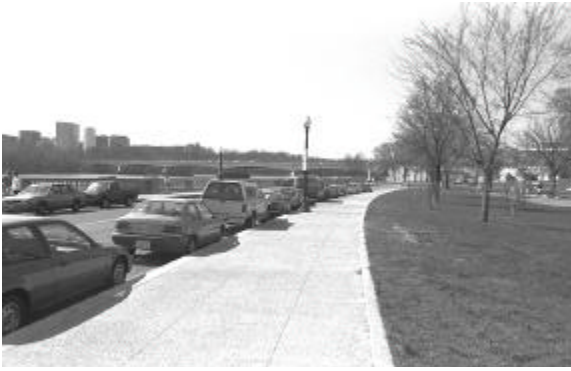
**Figure 104 - Sidewalk along Parkway Drive, April 1996. LINC 6-18.**

In contrast to the curving bridle trail on the south side of the bridge approach, two pairs of concrete sidewalks connected to the straight walks on both sides of the bridge and the parkway approach but did so by following the right angles of the north and south wing and plaza walls. The continuation of the bridge and parkway balustrades, with built-in benches, on top of the wing and plaza walls added a high degree of formality to this pedestrian area and gave visual definition to the outer edge of the plaza. The far walks, with their 90-degree turn at the corner of the wing walls,

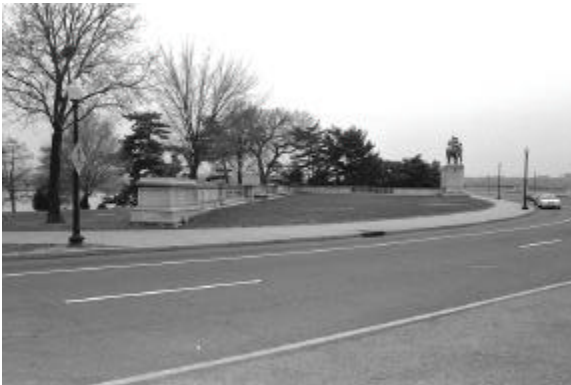
**Figure 105 - South plaza wing wall with new concrete path in same alignment as original bridle path, December 5, 1996. LINC 13-1.**

To accommodate the changes in recreational use, the bridle paths were modified to serve as both a pedestrian path and as a bicycle trail. An asphalt pathway was installed along the slope in the area north of the parkway approach and connected to the system of walks around the outer circle. In response to patterns of use, the concrete sidewalks located along both the north and south wing walls were removed, and new concrete walks were constructed along the curving curb edge of the bridge and parkway approaches, where a worn dirt path had been created. Even though the use of some paths have

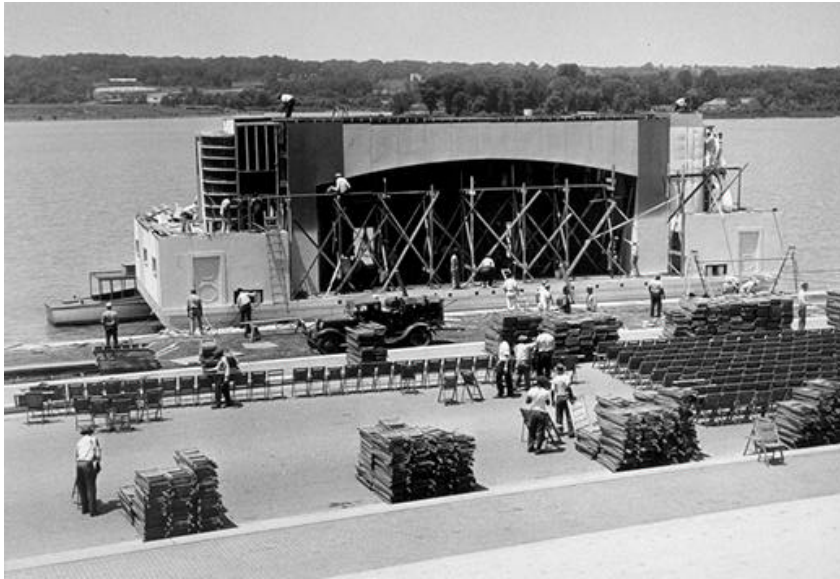
*Figure 106 - Watergate concert barge located at the base of the Watergate steps, July 19, 1939. MRC 1-1.*

Since the Watergate's original purpose as a ceremonial entry to the nation's capital never developed, other uses were sought for the area. An open-air summer series of concerts were proposed for the steps. An orchestra shell was constructed on a barge, secured to pilings, at the water's edge in 1937 and again in 1938. A third orchestra shell was

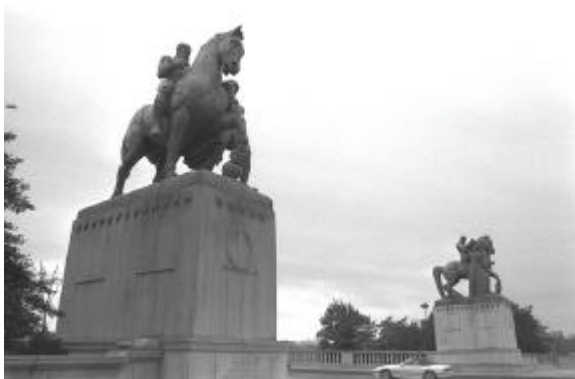
*Figure 107 - Valor and Sacrifice statues flank entrance to Arlington Memorial Bridge, February 1997. LINC 18-5.*

and south wing walls. At the entry from the plaza to the bridge and to the parkway approach, two pairs of granite pedestals were incorporated into the structure. These were intended to be the bases for four monumental sculptures. The pedestals stood empty, the sculptures awaiting funding, until 1951, when the installation and dedication finally took place. The large figural works of art were allegorical representations of Valor, Sacrifice, Music and Harvest, and Aspiration and Literature.

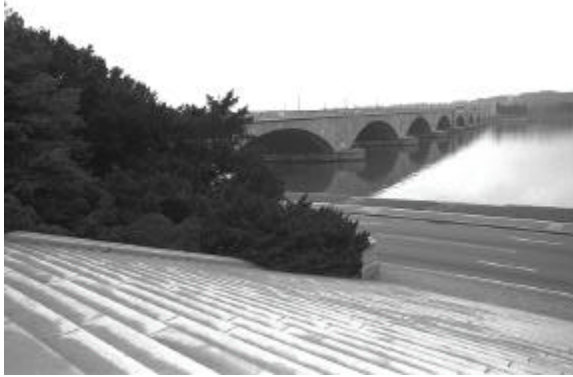
**Figure 108 - Ceremonial Watergate steps and Arlington Memorial Bridge, January 3, 1997.**  
**LINC 16-36.**

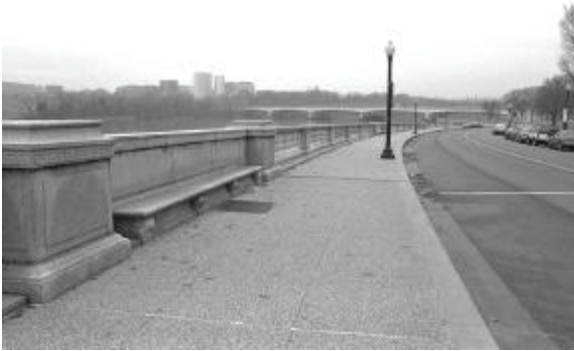
**Figure 109 - Granite bench built into river wall along Parkway Drive, January 3, 1997. LINC 16-3.**

**Benches.** Historically no provisions were made for free-standing park benches in the Watergate area. Even today, there are no free-standing benches provided for visitors, instead visitors can sit on the Watergate steps or use a more permanent seats where granite benches were built into the plaza wing walls and along the bridge approach walls for Parkway Drive and Arlington Memorial Bridge. Because the location of the granite benches along busy roads is unappealing to visitors, the benches are rarely used.

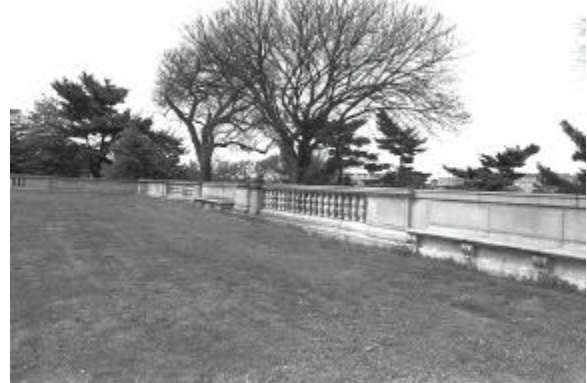
**Figure 110 - Granite benches built into Watergate plaza wing walls, April 1996. LINC 6-8.**

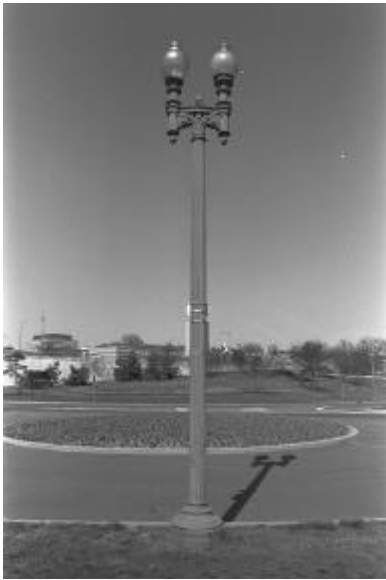
**Figure 111 - Twin-twenty lamppost at old terminus for Constitution Avenue, March 1996. LINC 6-20.**

**Lighting.** As with the Lincoln Circle and the radial roads, streetlights were limited to specific locations along routes for vehicles. Designs for Arlington Memorial Bridge and Parkway Drive incorporated the “Washington Globe” lamp and 18-foot post. On the bridge the lights were spaced evenly in opposite positions, while in all other locations they were set in an alternate arrangement. Along Parkway Drive the lampposts were originally planned to be on granite bases. Later the bases were removed and the posts were set on grade according to the established pattern of installation elsewhere in the Lincoln Memorial area. The “Washington Globe” lamp and post also illuminated the Watergate plaza area, at the top of the steps. Along Constitution Avenue at the northern boundary of the park, “Twin-twenty” lamps and posts were installed.

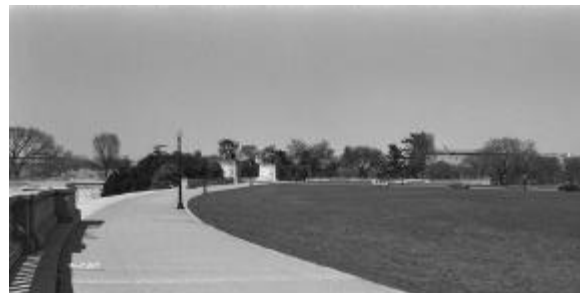
**Figure 112 - Washington Globe lamppost at the Watergate plaza, March 1996. LINC 6-14.**

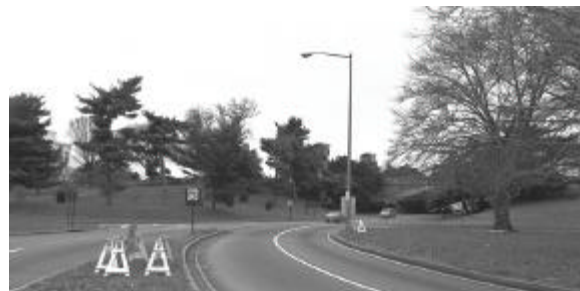
**Figure 113 - Cobra style lamppost along Ohio Drive, January 3, 1997. LINC 16-7.**
